North Bank Playground

Completed By: Patrick McCord

Date of Report: April 15, 2020

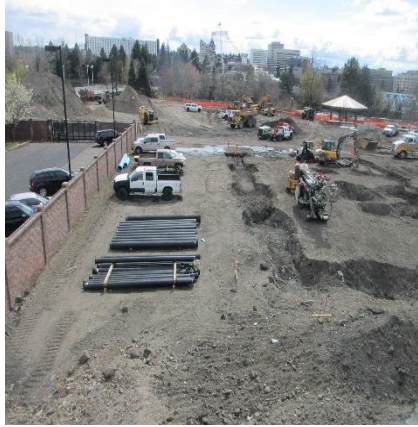
#1 View from cliff east side of the cliff (facing south).

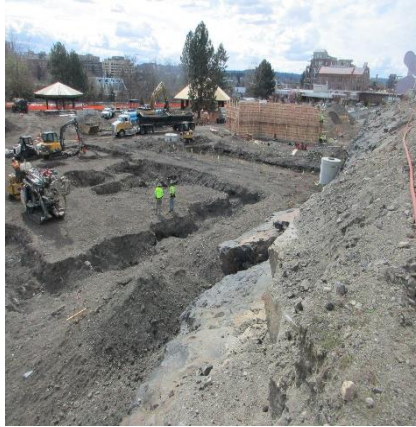
#2 View from east side of the cliff (facing west).

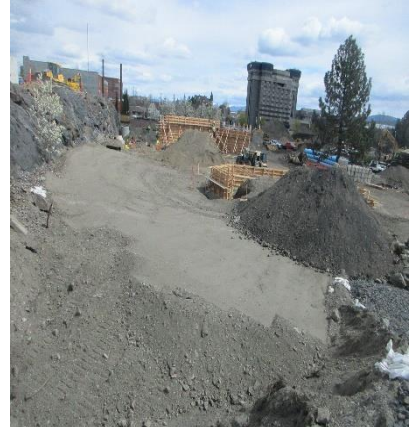
#3 View from west ramp (facing east).

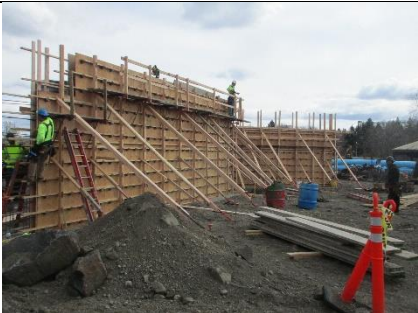
#4 West retaining wall at skate park

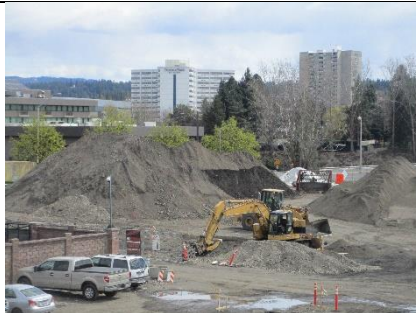
#5 East side stock piles.

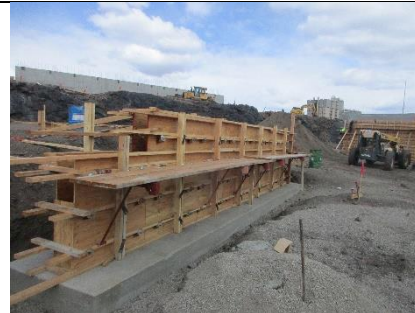
#6 West side site retaining wall.

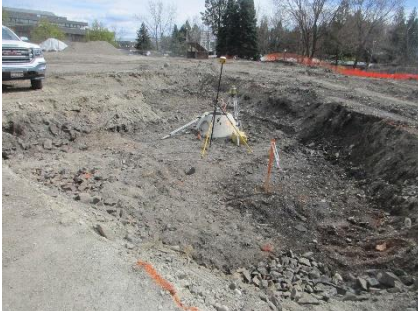
7 East side drywell.

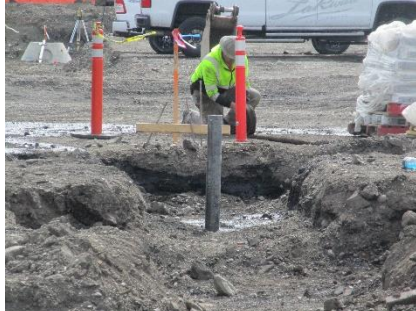
#8 Test pile.

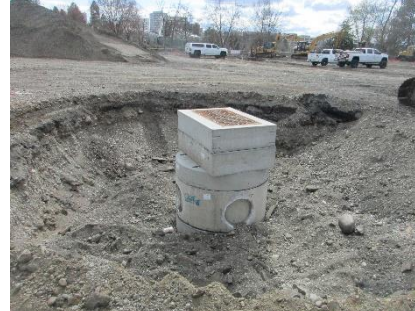
#9 Stormwater inlet.
